# **Ohmsett Tests of:**

# The CANFLEX "Sea Slug" Temporary Storage Device and the DOAS Flotation Collar

Michael Goodwin and Roland L. Custer

FINAL REPORT April 1995

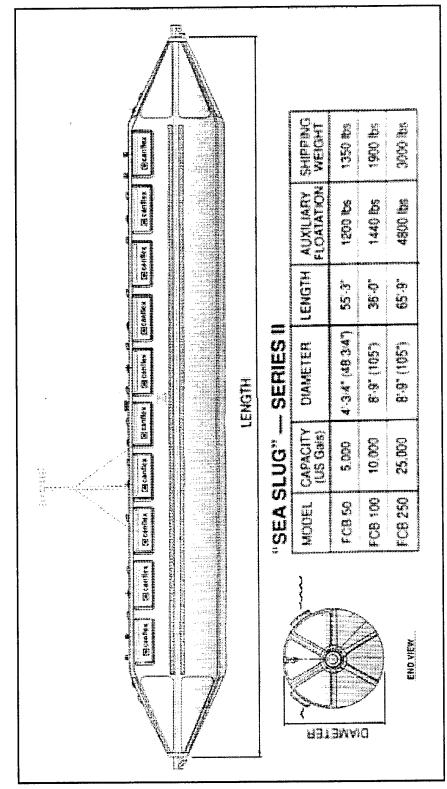
Figure 1 "Sea Slug" Temporary Storage Device

The CANFLEX™ "Sea Slug" Model FCB 250, shown in Figure 1, is a cylindrical fabric bag with conical ends, 65'-9" long and 8'-9" in diameter with a nominal capacity of 25,000 U.S. gallons of

liquid. The temporary storage device is made of PVC coated polyester fabric with a urethane liner. It is supported in the water when empty by 20 blocks of flexible closed cell foam inside fabric enclosures attached to the bag. The forward end connection is a cast aluminum cone with a 3" pipe fitting mounted on a plate. The after end connection is identical except the plate is replaced with one having a 10" flanged pipe which bolts to the DOAS valve. The DOAS was used to empty the bag. Along the top of the bag are a number of pressure relief valves and 4" filling connections as well as a 16" plate that is centrally located. The plate has a 6" female camlock fitting mounted on it. This fitting is the main fill connection point for the "Sea Slug."

The liner for the "Sea Slug" was particularly troublesome. It is not adequately attached to prevent it from being ingested by the DOAS. Any liner system must be attached to the outer container sufficiently to prevent pump blockage or pump ingestion. If not, the liner prevents offloading and will be an ineffective barrier if damaged by the pump. The difficulty experienced in cleaning the TSD when used with heavy oils leads to the conclusion that it may be cost effective to replace the

TSD rather than attempt cleaning after a major spill cleanup. If this approach is taken, the liner serves no purpose unless the outer shell will be chemically damaged by the oil. If possible, eliminate the liner.

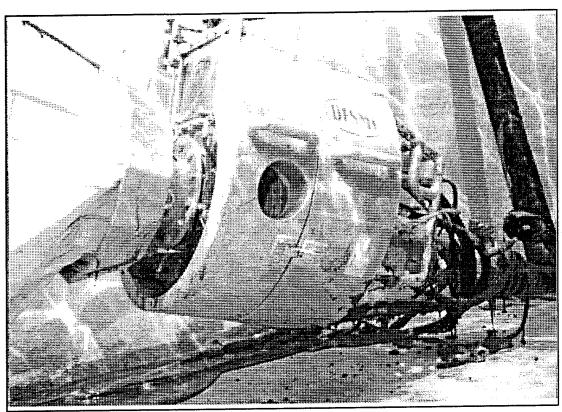
Figure 2 DOAS Attached to "Sea Slug"

The DOAS is shown in Figure 2, an underwater photograph of the DOAS attached to the "Sea Slug." The DOAS provides a knife gate valve, a DESMI DOP-250 pump, and a hydraulic control station for operating the system and interfacing with a hydraulic power source. The DOAS consists of two separate units mechanically and hydraulically joined together, (1) a hydraulically operated knife valve with a flotation collar (nearest to the temporary storage device) and (2) a DESMI DOP-250 pump inside a flotation collar. The two units are close-coupled with a 10" camlock fitting connecting the piping. The flotation collars are connected together by latches. The DOAS assembly mounts to the "Sea Slug" by means of a bolted 10 inch pipe flange.

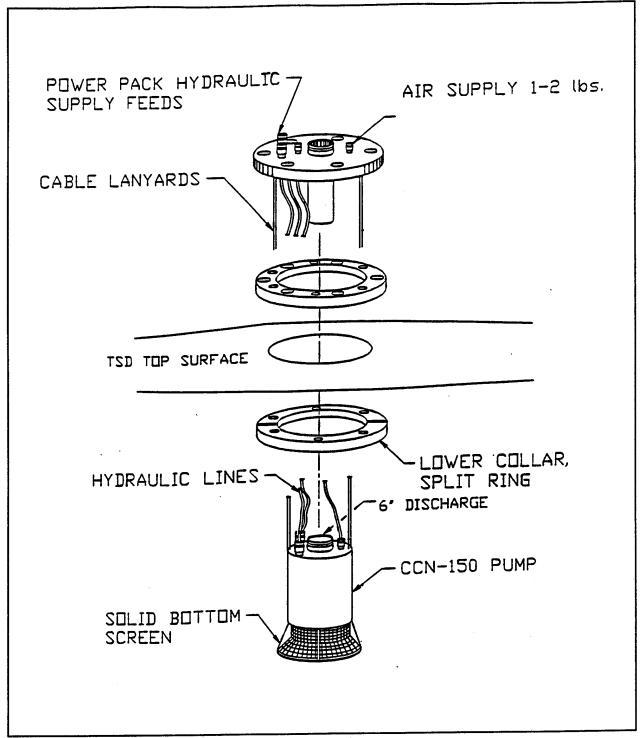
Figure 3 Arrangement for CCN 150 Pump Installation

In the Centrally Located Pump Offloading Tests, the CCN 150 pump was mounted as shown in Figure 3 through the top center opening in the "Sea Slug." The center plate on the top of the TSD was modified for this test. The existing 16 inch diameter ring was replaced by a 20 inch outside diameter, 16 inch inside diameter ring. A support plate was fabricated to bolt on top of the new ring. This support plate had connections for the pump discharge pipe, hydraulic connections and an air supply line for pressurizing the bag. The CCN 150 pump was suspended from this plate by two cable lanyards so that it was just at the bottom of the fully inflated bag.

The results from test 1 of the centrally located pump tests should be disregarded. It was found that the partially detached inner liner of the TSD was blocking the pump suction causing a much lower pumping rate than in tests 2 and 3.

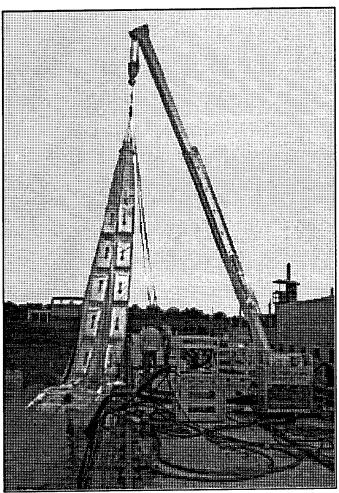
Figure 6 Crane Elevating Bow of TSD

In the Crane Lift Assisted Offloading Test the setup was as described earlier except that a crane was used to assist offloading as shown in Figure 6. After the transfer of oil from the storage tanks, a crane attached a line to the bow cone of the "Sea Slug" and the bow of the bag was raised in a series of lifts until the end point of practical offloading. The lifts were based on raising the "Sea Slug" until the crane was lifting 12,000 pounds. When pumping caused the load to drop to 6,000-8,000 pounds, the "Sea Slug" was again lifted until a load of 12,000 pounds was achieved. Pumping did not stop during lifts.

The crane lift method was superior to the other three DOAS methods tested. For practical purposed, all the fluid in the TSD was pumped out in a relatively short time. A full TSD, 25,000 gallons, likely could be emptied in 2 hours by this method. There was no evidence that the liner was being ingested in this test which may explain the improved results. Crane lifts were used on two other occasions to empty the TSD between tests. These were for operational purposes but data was collected on the offloading rates to supplement the data previously collected. In one of these tests, the pump stalled, probably due to liner ingestion. In the other test with very viscous oil, all the oil was emptied but the rate was considerably slower than with 50,000 cSt oil.

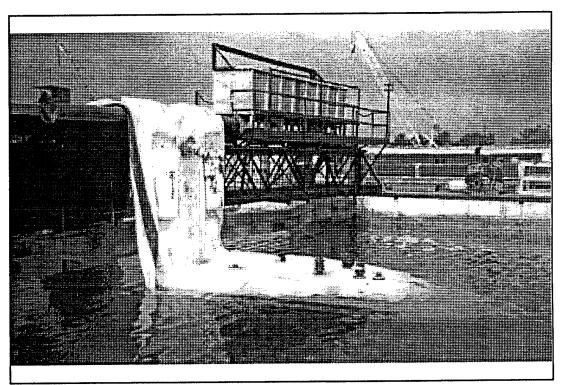
Figure 7 Fairlead Assisted Offloading Arrangement

The Fairlead Assisted Offloading Tests required a different setup as shown in Figure 7. The approach was to simulate the "Sea Slug" being pulled onboard a vessel by dragging the "Sea Slug" over a fairlead on the stern of the vessel. To simulate these conditions the auxiliary bridge was locked to the rails and the TSD was pulled over the top of the auxiliary bridge using the main bridge. The auxiliary bridge had a pipe fairlead (12" dia., 14 feet long) attached at the walkway level on the north side. A wooden ramp was constructed across the auxiliary bridge forward of the pipe fairlead. A tow line was attached from the bow of the "Sea Slug" across the auxiliary bridge's fairlead and ramp to the center of the main bridge. A load cell was placed inline with the tow line and main bridge.

The fairlead assisted technique worked much better than using the DOAS alone but still did not work acceptably well. Only about half of the initial 10,000 gallon load could be pumped out. Also, the time required was nearly 3½ hours. Again, this result may have been due to the TSD liner blocking the DOAS inlet, but this can not be confirmed. The long offloading time allowed the heated oil to cool resulting in a much more viscous oil at the end than at the start of offloading.

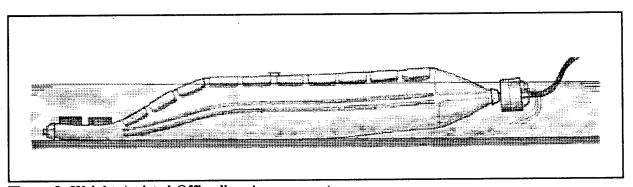
Figure 8 Weight Assisted Offloading Arrangement

The Weight Assisted Offloading Test was run with the equipment brought back to the original setup position. The idea behind this test was to add buoyancy to the DOAS end of the "Sea Slug" or add weight to the bow causing the "Sea Slug" to tilt and the oil to collect at the pump because of the difference in specific gravity of the oil and water. Enough buoyant material was not available to lift the stern of the "Sea Slug", therefore, 2,000 pounds of weight was placed on the bow of the "Sea Slug", forcing the bow to the bottom of the basin. This is illustrated in the artists sketch shown in Figure 8. The weights were positioned after the oil was transferred from the storage tanks to the "Sea Slug." The DOAS was started after the "Sea Slug" settled to its new position.

The weigh assisted offloading test worked better than the fairlead assisted method and is easier to implement provided a crane is available. Offloading was faster and less oil was left in the TSD. Liner ingestion was suspected in this test also.

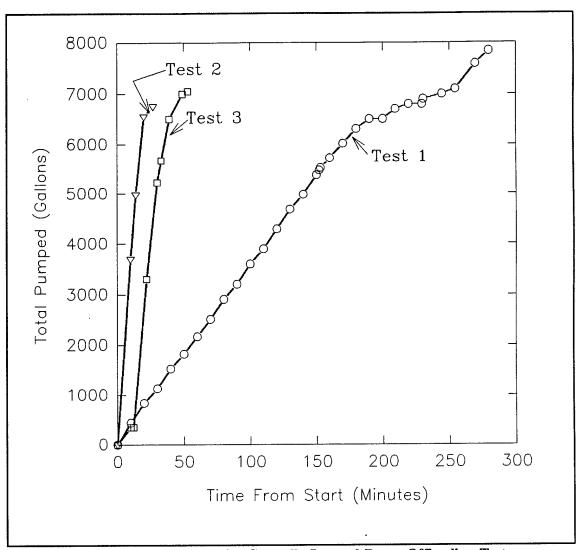
Figure 10 Plot of Discharge Rate for Centrally Located Pump Offloading Tests

Table 3 and Figure 10 show the results of the Centrally Located Pump Offloading Tests. The oil used in these tests was less viscous than that used in the tests with the DOAS pump. Oil viscosity was approximately 2,600 cSt versus 50,000 cSt plus for the DOAS tests. In these tests the TSD was pumped down to between 1,150 to 2,450 gallons remaining. However, these numbers are only approximate. They are based on the oil added versus the oil pumped out. There may have been some additional fluid in TSD after each test. Based on these quantities of fluid remaining, between 91 to 95 percent of the contents could be removed from a fully loaded, 25,000 gallon TSD. The offload rate varied from 20 minutes to offload 6,500 gallons in test 2 to 40 minutes to offload the same amount in test 3. However, the added time in test 3 was due to an initially slow pumping rate possibly caused by a clogged pump suction. This was cleared about 12 minutes into the run and the rate for the remainder of the run was similar to that of test 2. The test 3 rate indicates that a full offload (23,000 gallons) would take 2 hours and 21 minutes. The rate for test 2 indicates only half this time would be needed. The test 2 time is the more accurate barring clogging of the pump.

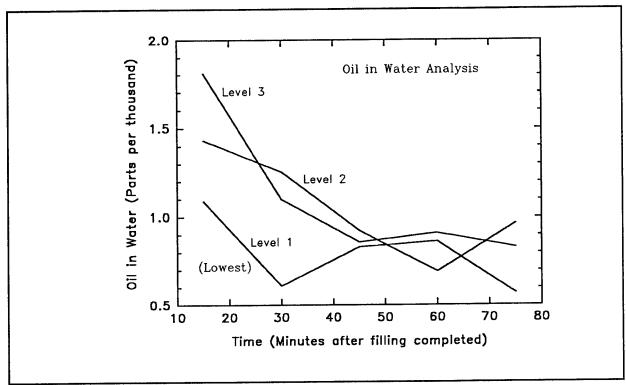
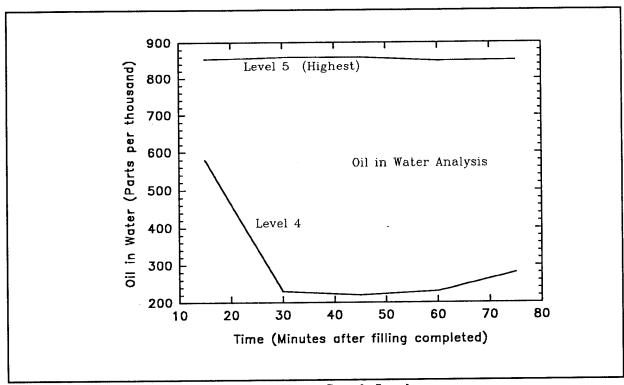
Figure 11 TSD Oil Separation Test - Three Lower Sample Levels

The samples were analyzed for oil in water using the infrared method with a spectrophotometer. The data is presented on two different graphs due to the large variation in the results. Figure 11 is the graph of the three lower levels measured. Figure 12 is the graph of the two uppermost levels measured. The graphs show no significant change with time in the highest level measured. The other levels go through a significant change in the first three sets of measurements, from 15 to 45 minutes. After one hour a reasonable steady state is achieved.

The lower portion of the liquid in the TSD could be decanted off on site provided that water with 1 part per 1000 of oil can be discharged. There is not a sharp break line between oil and water but the amount of oil in the water below the theoretical break line does fall off very rapidly after a short settling time. The fluid remaining after decanting can be expected to have between 20 to 80 percent water in it. Much of this water may be held in an emulsion with the oil.
